# Impact of hydrogeological factors on geotechnical conditions of the Kyiv-Pechersk Lavra Monastery complex: lessons from three decades of monitoring

Iryna CHEREVKO<sup>a</sup>, Tetiana KRIL<sup>b</sup>, Dmitri BUGAI<sup>b</sup>

Cherevko, I., Kril, T., Bugai, D., Shekhunova, S., (2024). Impact of hydrogeological factors on geotechnical conditions of the Kyiv-Pechersk Lavra Monastery complex: lessons from three decades of monitoring

The Kyiv-Pechersk Lavra monastery, located in Kyiv on the Right Bank of the Dnipro River, is a site of significant historical and cultural heritage. The review and analysis of data from the long-term (since the 1990s) groundwater monitoring studies of the Kyiv-Pechersk Lavra show that hydrogeological hazards caused by a complex combination of natural and anthropogenic factors (as well as sometimes by engineering miscalculations) have led to a significant number of emergencies that threaten the heritage architectural monuments. Monitoring and analysis of data illustrate a wide range of hydrogeological hazards (flooding, subsidence, landslides, suffusion), and emphasize the importance of consideration of hydrogeological aspects for safeguarding architec

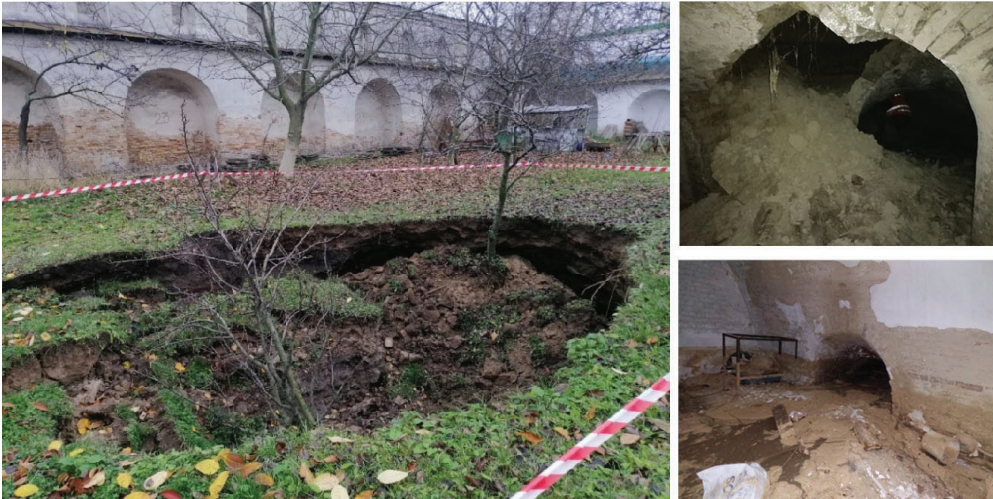
The above-mentioned accidents led to the formation of the perched aquifer, sharp rises in groundwater levels, flooding of foundations, water saturation, deformation of building walls, etc. In 1994, a heating water pipeline breakdown on the Economic Yard of the Upper Lavra territory led to the rise of groundwater level by 4.6 m. The water main accidents in 1998 – 2008 led to groundwater level rises of 1.5 – 2.4 m. This resulted in water saturation of the lower part of the loess soil strata, its compaction, and uneven subsidence of foundations of buildings with the formation of structural cracks (Figures S9-S11 in SI). The last large-scale emergency occurred on 27 October 2022 because of accidental leakage from the heating water pipeline, which runs across the Upper Lavra through the territory of the Metropolitan's Garden. As a result, three large (up to 2 m deep) sinkholes were formed on the ground surface with a total area of 140 – 150 m<sup>2</sup>. The underground structure – “Metropolitan's Wine Cellar” was flooded entirely and partially ruined (Fig. 5).

Fig. 5 - Photographs of sinkholes in the territory of the Metropolitan's Garden and the soil suffusion in the Metropolitan's Wine Cellar caused by the accident in October 2022.

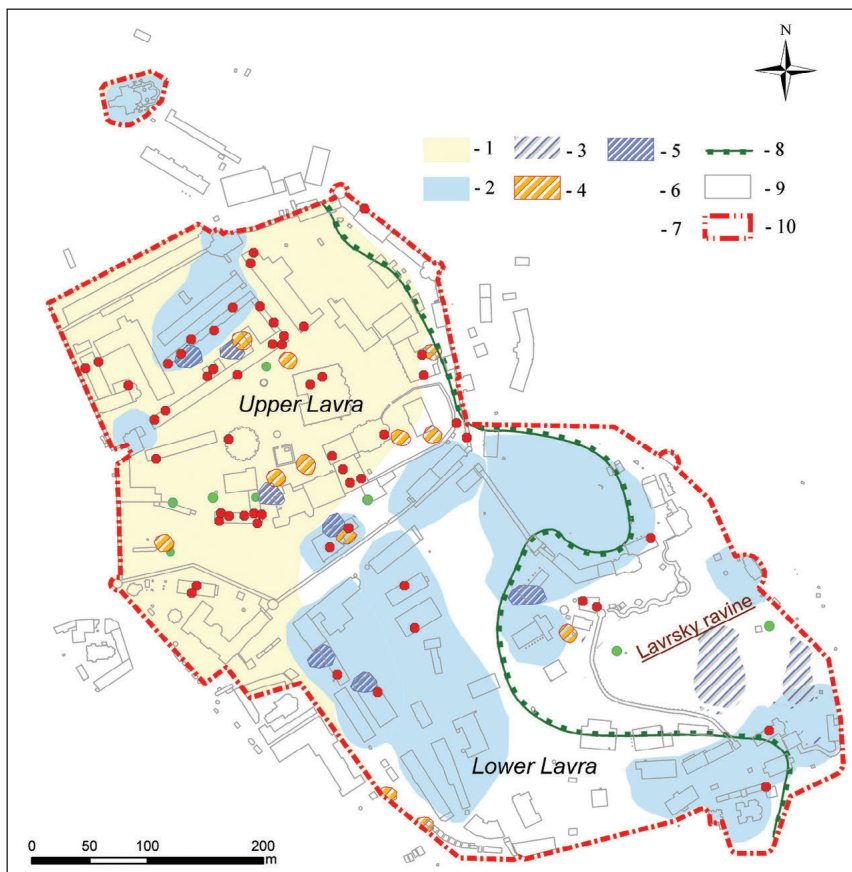
buildings; in 11 cases soil suffusion processes have led to the formation of sinkholes and subsidence, leading to deformations of the underground structures). The generalized scheme of manifestations of dangerous geological and hydrogeological processes within the Kyiv-Pechersk Lavra is shown in Fig. 6.

Fig. 6 - Schematic map of hazardous geological and hydrogeological processes in the Kyiv-Pechersk Lavra. Legend: 1- zone of potential subsidence, 2 - flooding by groundwater, 3 - stabilized landslides, 4 - suffusion sinkholes, 5 - flooding by surface water, 6 - manifestation of deformations and cracks in buildings, 7 - subsidence sites and sinkholes, 8 - boundary of landslide hazard zone, 9 - buildings, 10 - boundaries of Lavra.

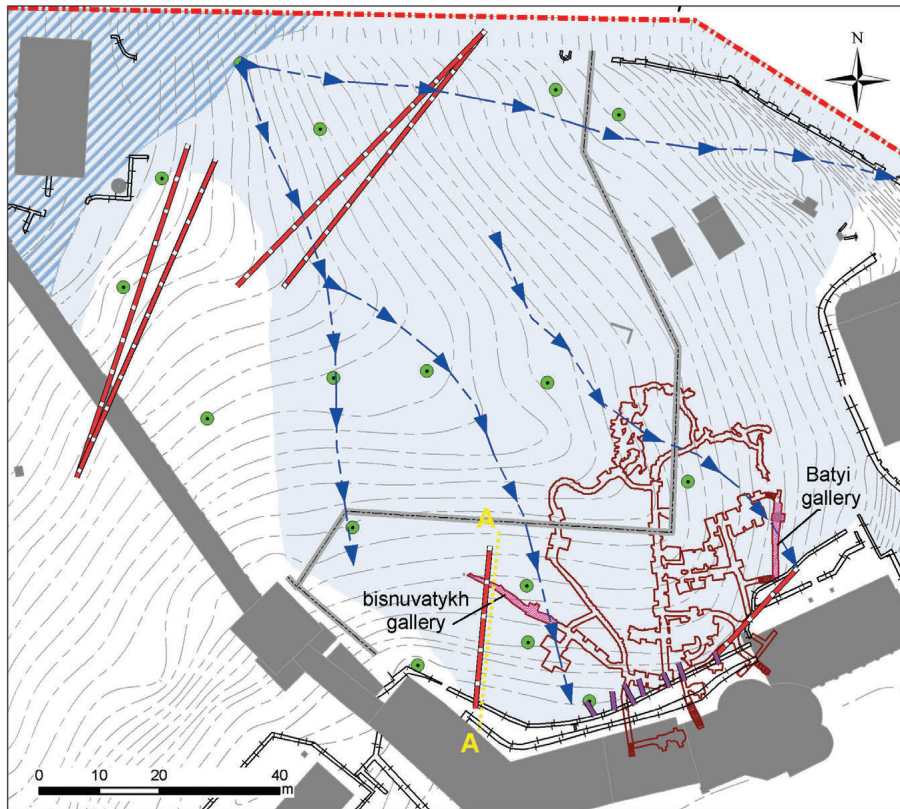
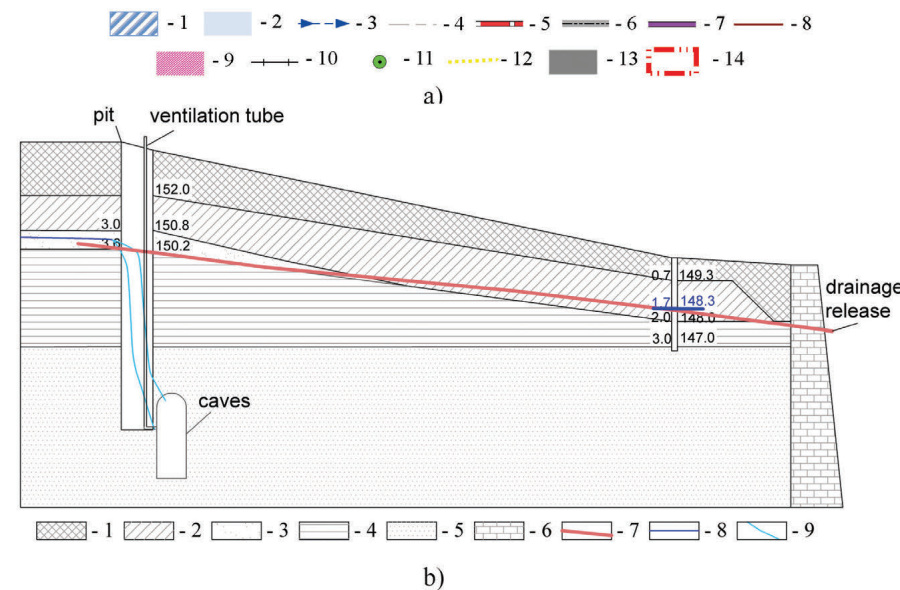
Fig. 7 - (a) Scheme of hydrogeological conditions, locations of accidents, and engineering mitigation measures at the Near Caves site. Legend: 1 – zone of the permanent aquifer in Quaternary deposits, 2 – zone of the temporary aquifer (as on March 03, 2019), 3 – groundwater preferential flow path lines, 4 – ground surface isolines, 5 – horizontal drainage, 6 – surface stormwater apron, 7 – drainage holes in the retaining walls, 8 – cave galleries, 9 – locations of accidents in caves, 10 – retaining walls, 11 – monitoring wells, 12 – line of the geological section A-A; 13 – buildings; 14 – boundary of Lavra. (b) - Geologic cross-section along the A-A line: 1 – man-made soils, 2 – diluvial soils (clay loams, sandy loams), 3 – diluvial soils – sands with interbeds of clay loams, 4 – brown clays, 5 – sandstones, 6 – retaining wall, 7 – horizontal drainage, 8 – groundwater level, 9 – pathways of inflow of groundwater to caves before construction of drainages.

geophysical surveys aimed at investigating the cause of emergency allowed to develop the following conceptual model of ingress of groundwater to the Near Caves (Starostenko et al., 2007; Cherevko et al., 2015, 2017). The permanent groundwater aquifer in Quaternary deposits is present only in the upper part of the Near Caves Hill (see Fig.7). In the rest of the territory, groundwater occurs temporarily as it spreads over the surface of the low permeable clay layers under influences of seasonal rainfall or snowmelt. In general, the formation of this temporary aquifer occurs due to the infiltration of atmospheric precipitation (the main component), the lateral inflow of groundwater from the territory of the Upper Lavra, and losses from local water networks (e.g., storm drains). The seasonal and episodic (caused by the anthropogenic factors) infiltration recharge leads to the lateral spread of groundwater towards the cave tunnels, which are located downslope, along the preferential flow paths in permeable lenses of sandy loams and loams overlying the eroded surface of brown and variegated clays. The groundwater accumulation above the caves is caused by water retention due to the retaining walls (“barrage effect”) along the southern and southeastern perimeter of Near Caves Hill. In addition, infiltration of groundwater into the cave complexes can occur through the preferential flow paths in the clay layer above the caves, which were created due to natural (landslide-induced cracks) or anthropogenic factors (e.g., in the ventilation hole to the caves, or through insufficiently compacted soil in the pit excavated for the repair works). The conducted research allowed the development of mitigation measures for the Near Caves.
