# Impact of hydrogeological factors on geotechnical conditions of the Kyiv-Pechersk Lavra Monastery complex: lessons from three decades of monitoring

### Supplementary file - *File supplementare*

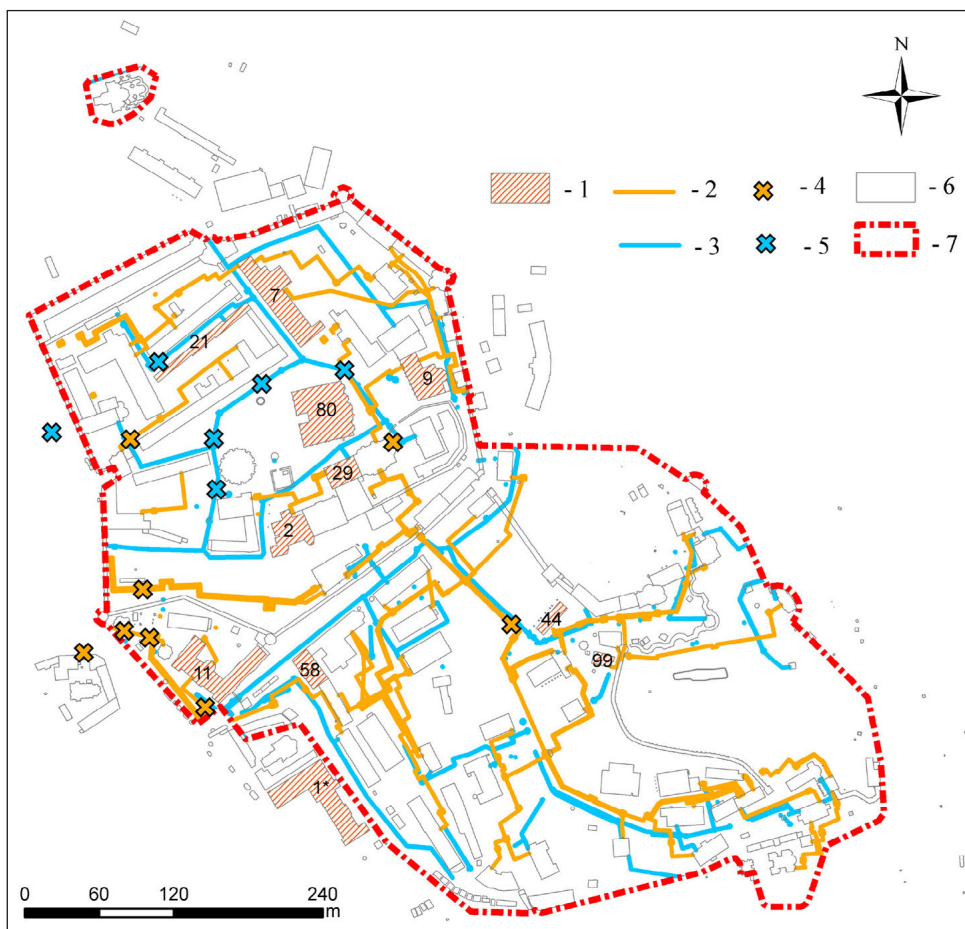
Fig. S3 - Schemes of the water mains on the territory of the Kyiv-Pechersk Lavra with marked locations of accidents caused by water mains breaches. Legend: 1 – buildings, which were impacted by accidents, 2 – heated water pipelines (hot water - 60°C), 3 – water mains, 4 – accidents on heated water pipelines, 5 – accidents on water mains, 6 – buildings, 7 – the boundary of Lavra.

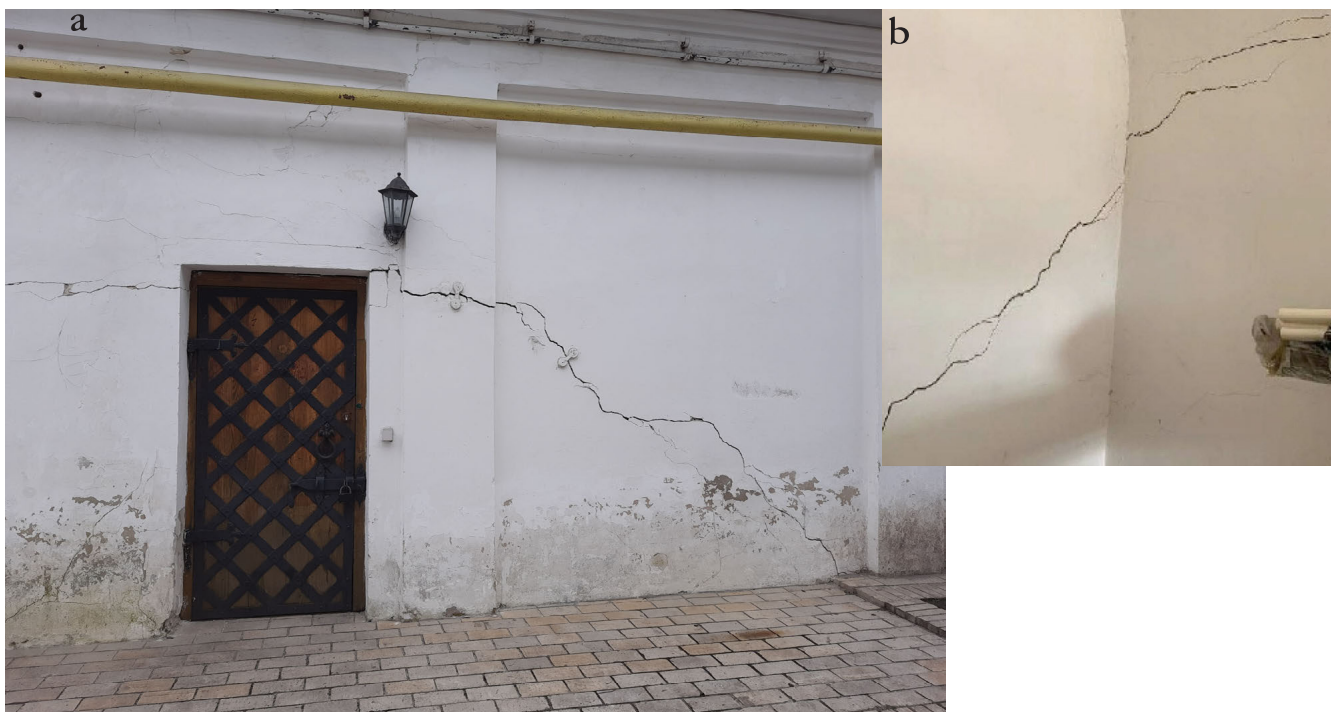
10	October 2021	A long-term leakage from the water main in the Upper Lavra has led to total excessive saturation of soils, uneven subsidence of foundations, and cracking in the eastern part of the northern facade of building no. 21 (the opening of the cracks reached 1.6 cm); all inspection wells along the water main were flooded. In addition, existing cracks were re-activated and new cracks were formed on the northern and southern facades in the interiors of the building (Fig. S10)
11	October 2022	An accidental leakage from the main heat water pipeline, which runs across the Upper Lavra through the territory of the Metropolitan's Garden resulted in were forming of three big up to 2 m deep sinkholes on the ground surface with a total area of $140 - 150 \text{ m}^2$ . An underground structure - "Metropolitan's Wine Cellar" was completely flooded and partially ruined.
12	July - August 2023	A sequence of large-scale breaks of water mains and heat pipelines at the corner of the Citadelnaya and Lavrskaya Streets and along Lavrskaya Street resulted in flooding of the basement of the building of the Museum of Ukrainian Folk Art, rise of groundwater levels in the observation wells located along the Lavrskaya Street by 0.7 - 1.7 m and an increase of the groundwater temperature

*Fig. S10 - Cracks on the facade (a) and in interior premises (b) of Building no.21 caused by uneven subsidence of foundations (photo was taken on October 2021).*

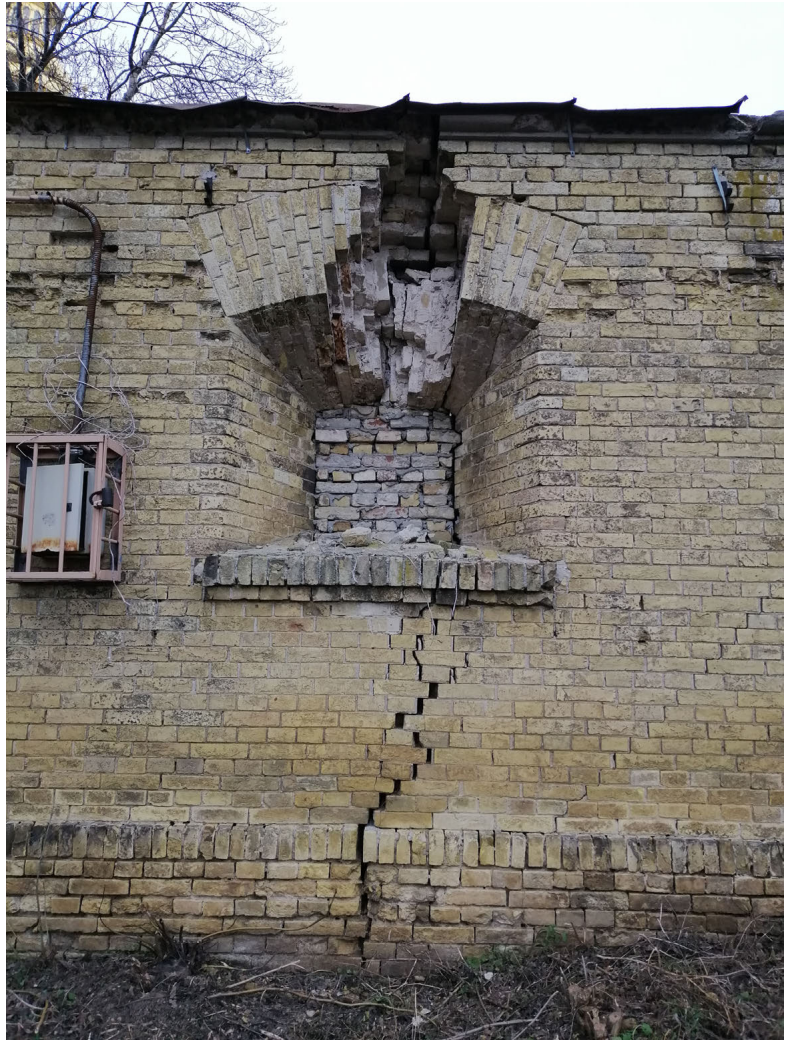
*Fig. S11 - Crack in the defensive wall of Lavra (photo was taken in March 2024).*
